# Zimbabwe

## Quantifying destruction - satellite images of forced evictions

8 September 2006  
AI Index: AFR 46/014/2006

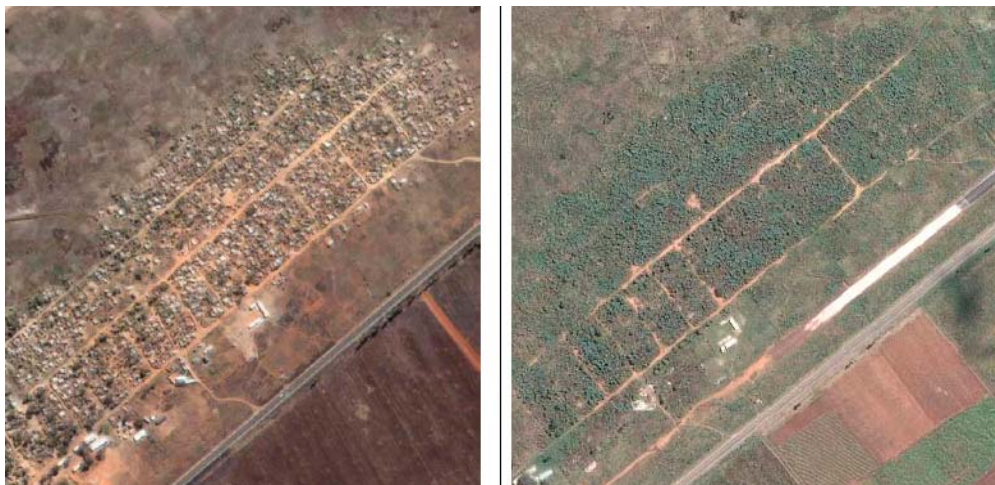
**Figure 1: Porta Farm Before and After Operation Murambatsvina**

High resolution satellite imagery of the Porta Farm settlement in Zimbabwe. More than 850 structures are visible in the before (left hand) image, practically all of which are absent from the after (right hand) image. Note that the significant difference in colour between the images is due to seasonality as the before image was captured during the dry season while the after image was acquired during the rainy season. Images (C) COPYRIGHT 2006 DigitalGlobe, Inc. ALL RIGHTS RESERVED.

Two QuickBird satellite images were obtained covering the area of Porta Farm, including a “before” image from 22 June, 2002 and an “after” image from 6 April 2006 (see Figure 1).<sup>6</sup> The satellite images clearly show Porta Farm in 2002 as a vibrant settlement while only some of its roads and vegetation remain in 2006.

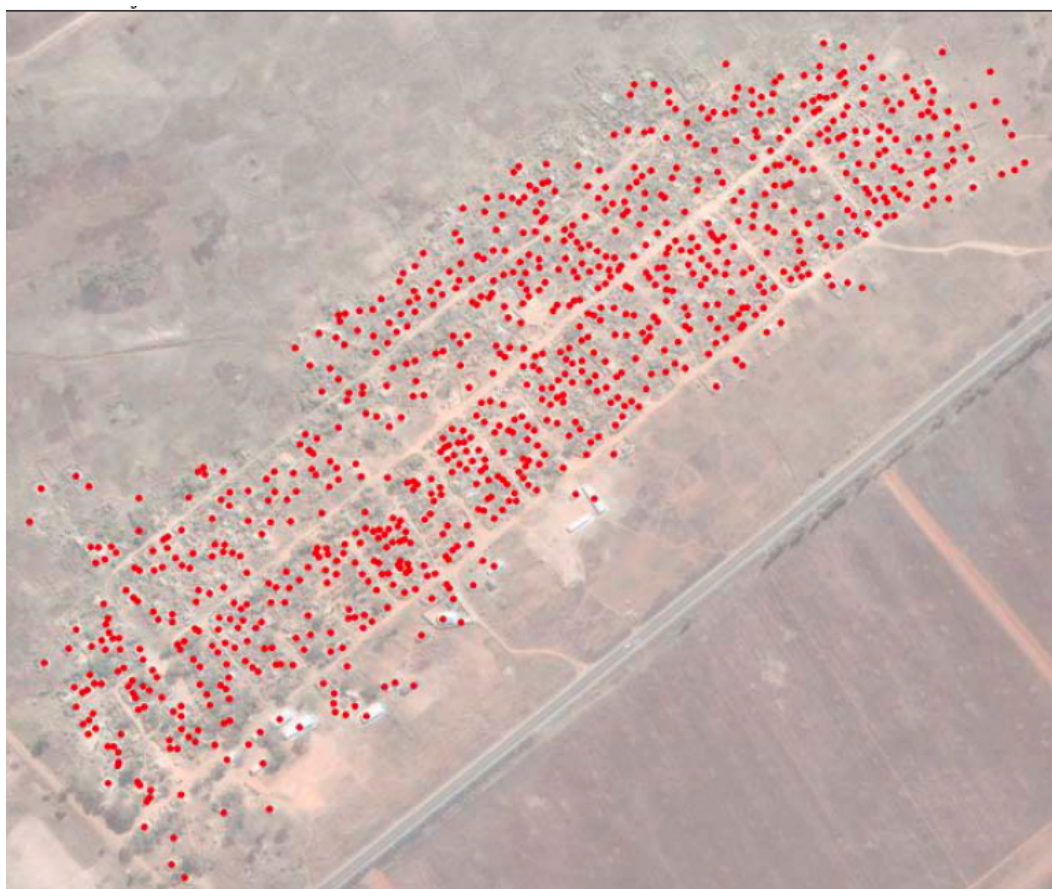
**Figure 2: Porta Farm Structure Count**  
The Porta Farm settlement with centre points of destroyed structures.  
Images (C) COPYRIGHT 2006 DigitalGlobe, Inc. ALL RIGHTS RESERVED

Visual analysis of the 2002 image was undertaken to determine the approximate number of structures removed during the interim period. Specifically, the 2002 image was loaded in ArcView GIS and individual visible structures were counted (see Figure 2). A total of 870 structures were counted. The majority are absent from the “after” image. Based on image analysis, more than 850 structures were apparently removed during Operation Murambatsvina.

The dimensions of the settlements and its structures were also measured, indicating a long axis of 1017 meters and a short axis of 257 metres for Porta Farm. The size of the structures themselves varied quite widely, with small structures measuring four meters on a side and larger structures measuring up to 40 square meters and more.

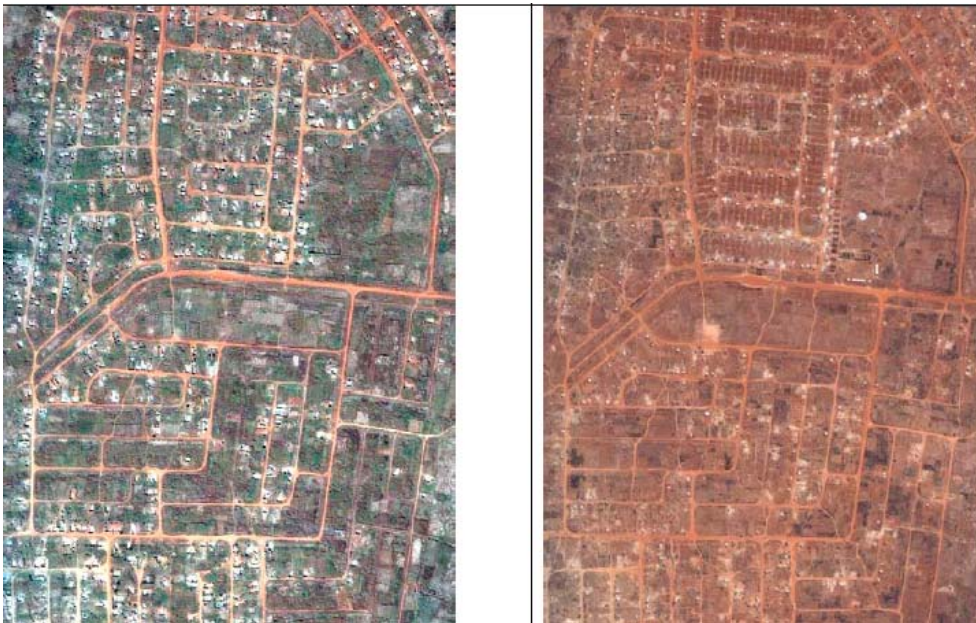
**Figure 3: Hatcliffe Extension New Stands Before and After Operation Murambatsvina**

High resolution satellite imagery of the Hatcliffe Extension New Stands settlement in Zimbabwe. More than 700 structures are visible in the before (left hand) image, most of which are absent from the after (right hand) image. Note that the significant difference in colour between the images is due to seasonality as the before image was captured during the dry season while the after image was acquired during the rainy season.

Four QuickBird images were obtained.<sup>7</sup> The first set of images (Figure 3) shows a “before” image from 14 May 2004 and an “after” image from 2 September 2005 of the area of Hatcliffe Extension known as Hatcliffe Extension New Stands. The satellite imagery clearly shows the settlement in 2004 while the 2005 image shows most homes removed.

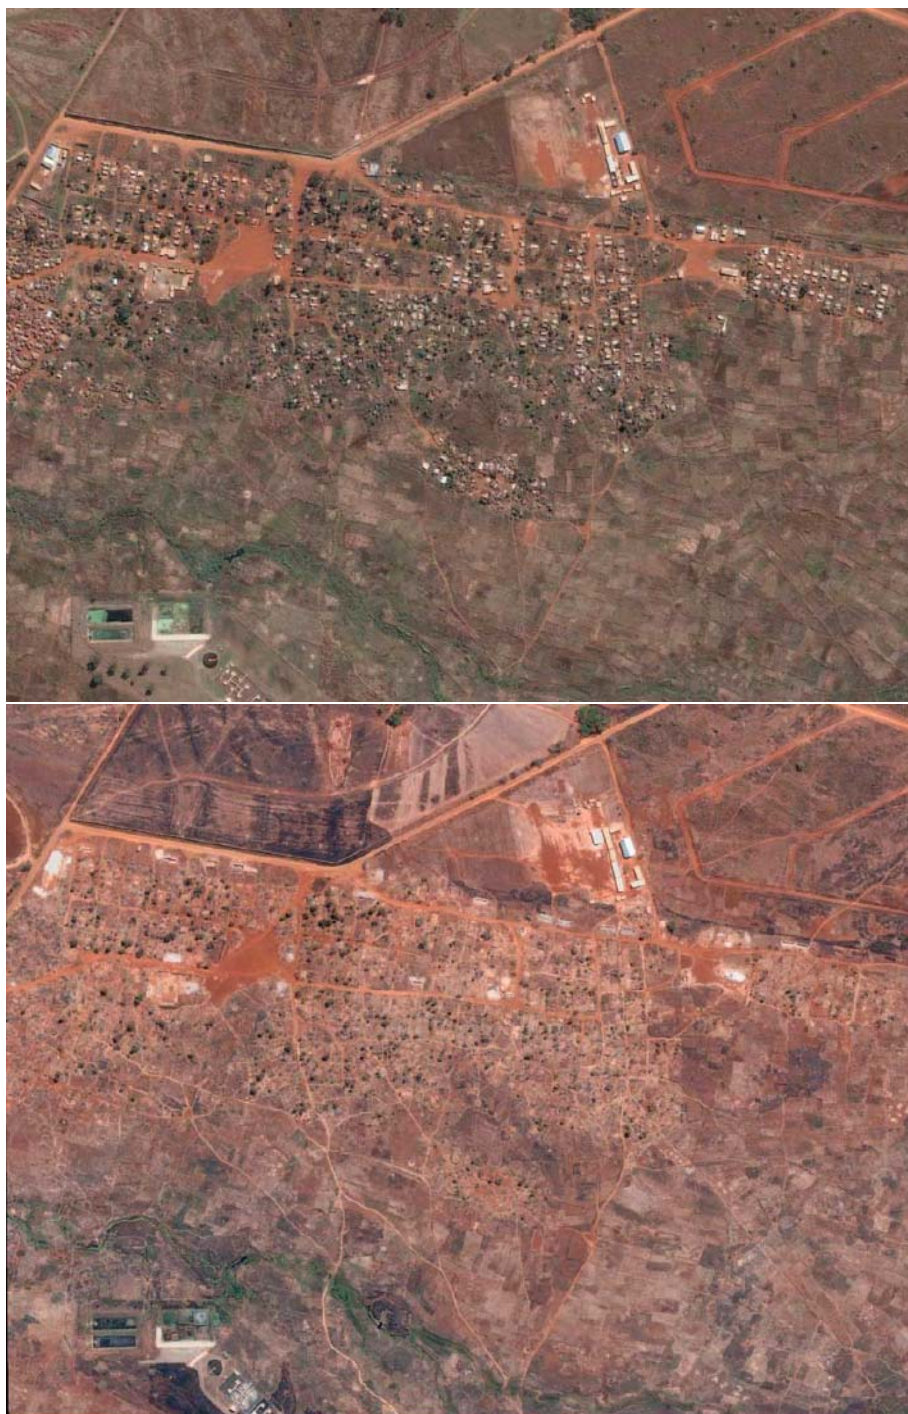
**Figures 6 and 7: Hatcliffe Extension Holding Camp Before and After Operation Murambatsvina**  
These images show a “before” image from 14 May 2004 and an “after” image from 2 September 2005 of Hatcliffe Extension Holding Camp.

As before, the images were analysed to determine the approximate number of structures destroyed. This analysis revealed a total of 764 structures visible in the “before” image of Hatcliffe Extension New Stands and 875 structures visible in the “before” image of Hatcliffe Extension Holding Camp, which were absent from the “after” images. In addition, an undetermined number of backyard structures were also possibly removed from the nearby formal suburb of Hatcliffe.

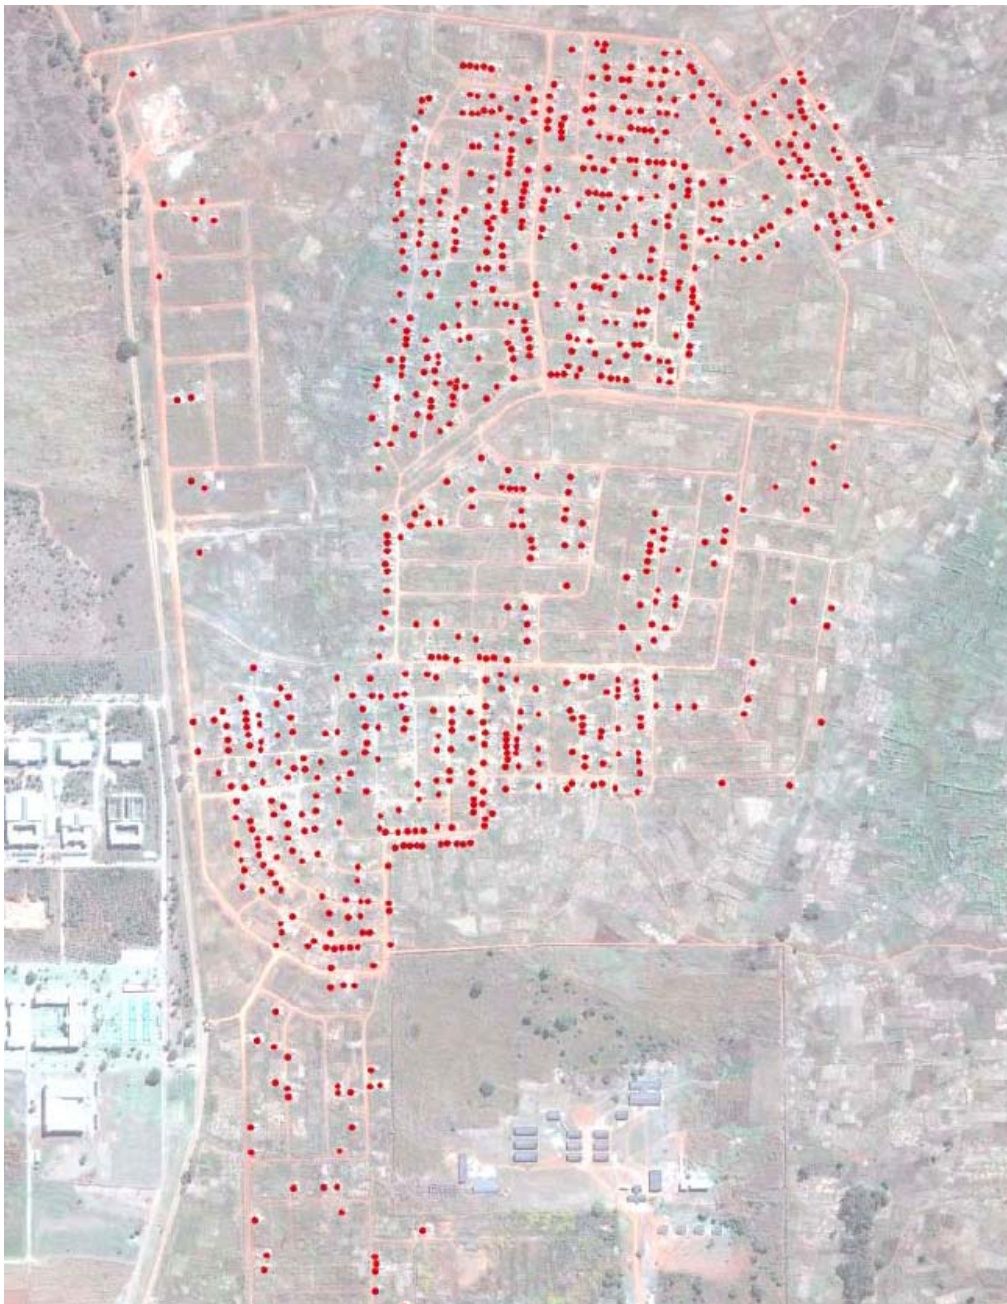
**Figure 8: Hatcliffe Extension New Stands Structure Count**

The Hatcliffe Extension New Stands settlement with centre points of destroyed structures. Images (C) COPYRIGHT 2006 DigitalGlobe, Inc. ALL RIGHTS RESERVED.

The size of structures themselves varied quite widely, with small structures measuring four meters on a side and larger structures measuring up to 40 square meters and more.

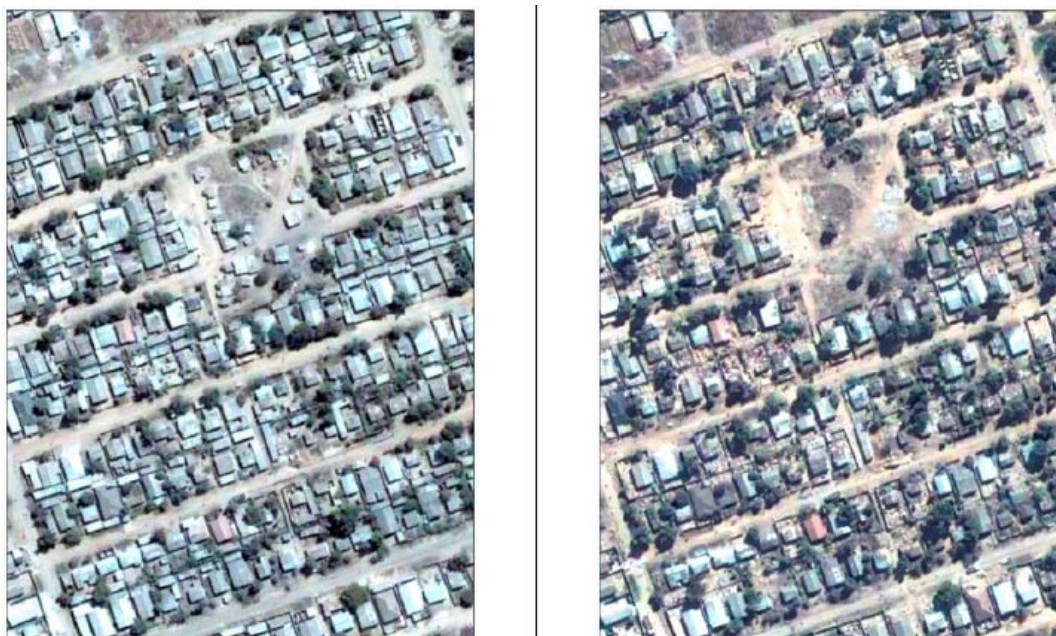
**Figure 9: Chitungwiza Before and After Operation Murambatsvina**

A subset of the high-resolution satellite imagery of Chitungwiza town in Zimbabwe. Backyard homes are visible in the left-hand (before) image and are the smaller structures found on the periphery and in the alleys of larger structures, which are absent from the right-hand (after) image. In addition, what appears to be a marketplace seen in the “before” image is absent from the after image.

Analysis of the images indicates widespread demolition of backyard homes. Backyard homes were essentially built on small patches of land leased to renters by owners of larger, permitted structures (see Figure 9). Amnesty International researchers visited the St. Mary’s area in August 2005, at which time the evidence of the demolitions was widespread. Almost every house in St. Mary’s was surrounded by the brick rubble of destroyed backyard structures. Foundation slabs were clearly visible in many cases, and people were evidently living in the gardens and on verandas.

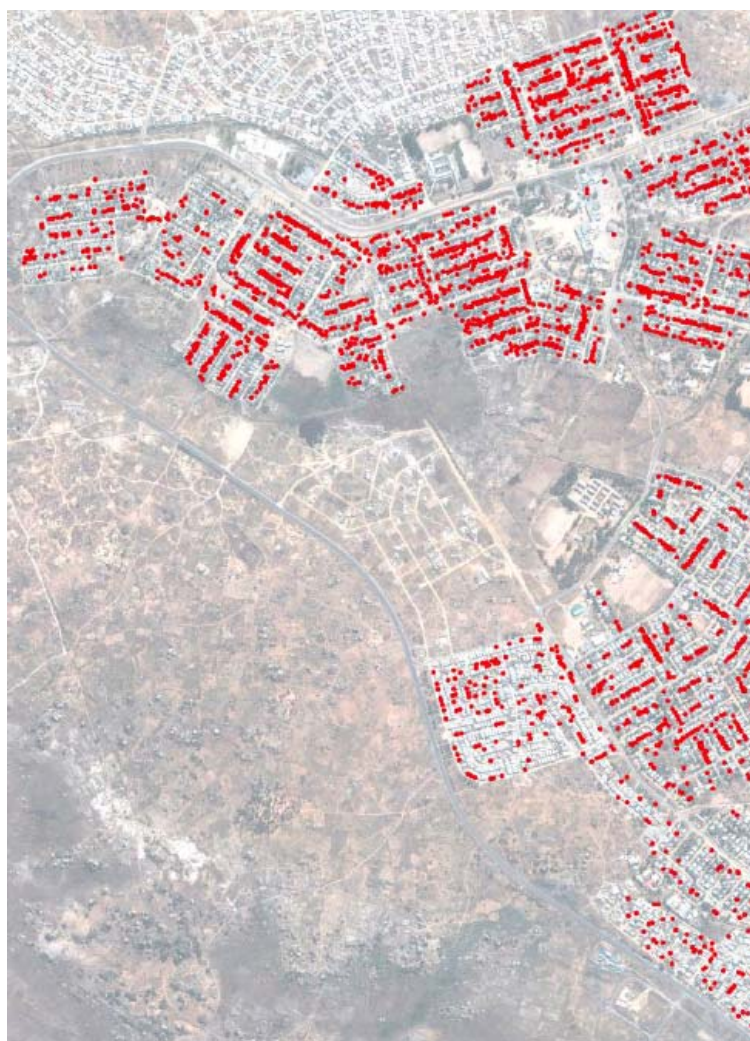
**Figure 10: Chitungwiza Structure Count**

Chitungwiza on 22 June 2005 with centre points of the 2470 removed structures.  
Images (C) COPYRIGHT 2006 DigitalGlobe, Inc. ALL RIGHTS RESERVED.

Analysis of the satellite images shows more than 2,000 backyard structures were removed in the portion of Chitungwiza captured by the satellite image. In addition, at least one marketplace in Chitungwiza was destroyed during the operation. In total, analysis of the satellite imagery indicates that 2470 structures were removed from this portion of Chitungwiza during Operation Murambatsvina. The size of structures themselves varied quite widely, with small backyard homes measuring 4 meters on a side and larger market structures measuring up to 40 square meters and more.

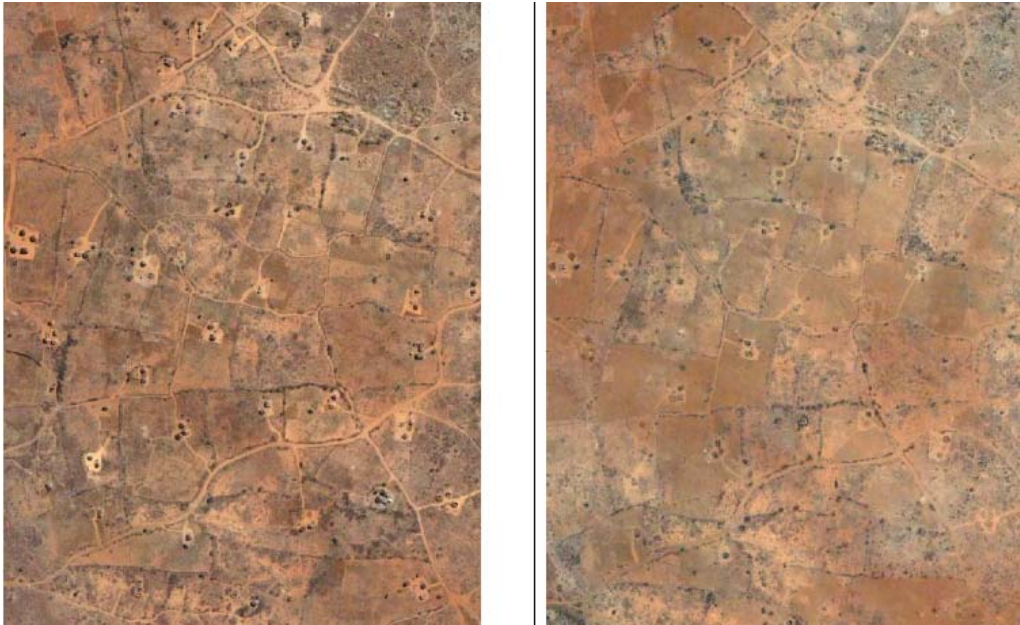
**Figure 11: Killarney Before and After Operation Murambatsvina**

A subset of the high resolution satellite imagery of the Killarney settlement in Zimbabwe. Note that the entire settlement of Killarney that was destroyed measured more than three kilometers from north to south and 1.6 kilometres east to west. Given the small size of the structures, they would not be visible were the full extent of the image shown. Some of the more than 465 Killarney structures are visible in the before (left hand) image, most of which are absent from the after (right hand) subset image. Images (C) COPYRIGHT 2006 DigitalGlobe, Inc. ALL RIGHTS RESERVED.

The informal settlement at Killarney, outside Bulawayo, was destroyed in June 2005 as part of Operation Murambatsvina. Two QuickBird images were obtained covering the area including a “before” image from 22 August 2004 and an “after” image from 7 September 2005.<sup>9</sup> The satellite imagery clearly shows the settlement in 2004 while the 2005 image shows most homes removed.

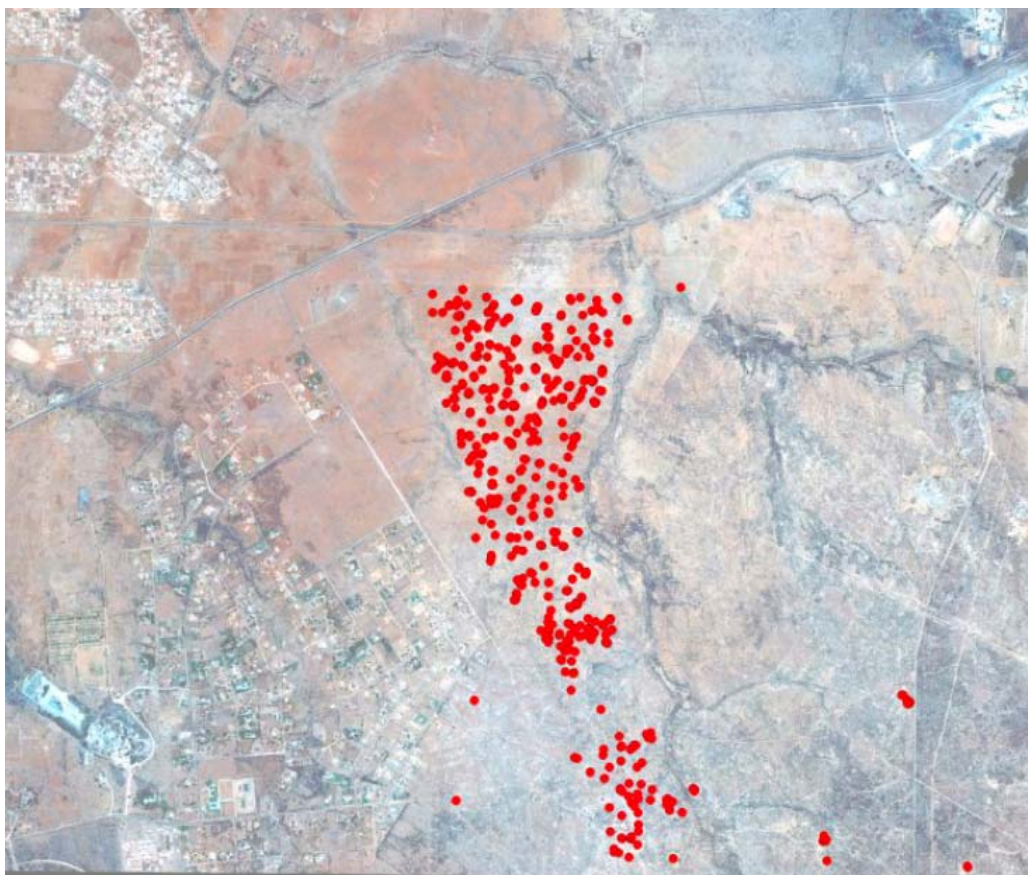
**Figure 12: Killarney Structure Count**

The informal settlement of Killarney (removed structures too small to be seen at this resolution). Centre points of the 486 removed structures.

A total of 486 structures were counted in the primary area of removal. The sizes of the structures themselves were generally quite small, measuring four meters on a side and smaller. One household many have comprised several small buildings.
